# Kourion Urban Space Project: Preliminary Report of the 2018 Season

**Abstract:** The 2018 season of the Kourion Urban Space Project (KUSP) continued the excavation of Building 4, a large structure situated just to the southwest of the Earthquake House on the Kourion promontory. Focusing on tracing the architecture of this building, this season revealed the northwest perimeter wall and identified two internal rooms: the courtyard and Room 35. Building 4 continues to yield high quality and imported artifacts including glass vessels and fragments of marble statuary along with imported marble and stone construction materials. These artifacts combined with the overall large size of this structure and construction materials suggest that this building served the elite class at Kourion, though it is still uncertain if it served a public or private purpose. This report was lodged with the Department of Antiquities, Cyprus, in January 2022 and is published here with the authors' affiliations as they were at the time of the excavation.

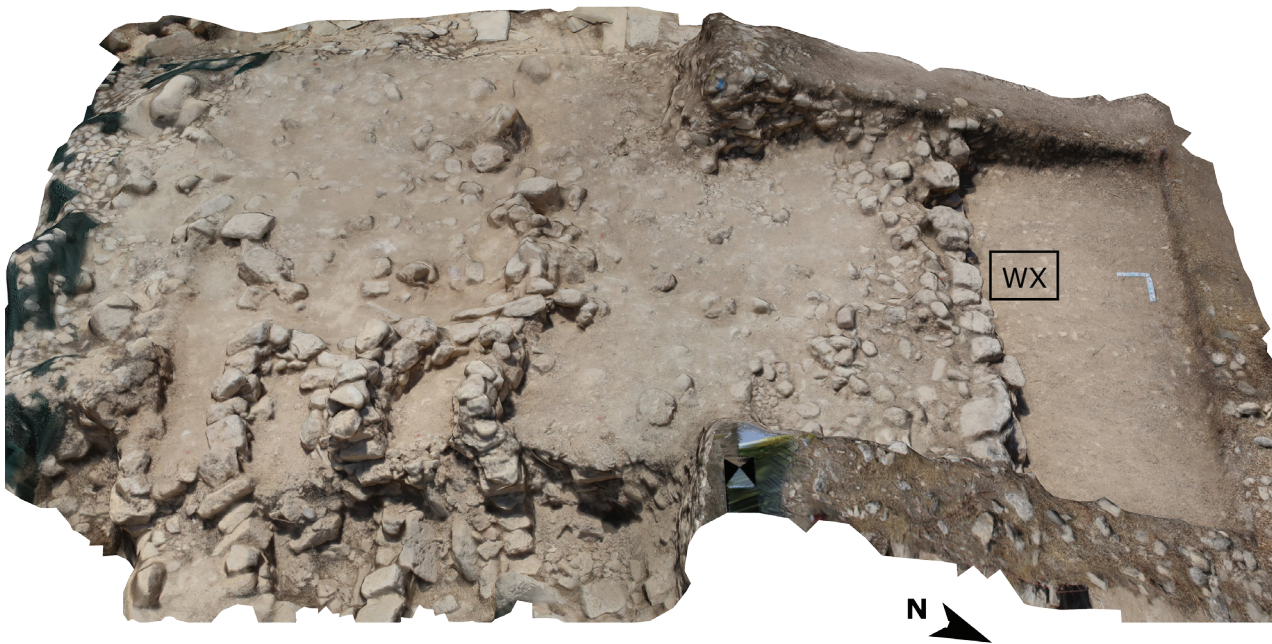
**Figure 4:** A 3D view Units 10, 11 and 16. The three slumped walls in Room 35 are in the foreground. The view is looking southwest. Image: generated by Agisoft Photoscan.

Room 35 is difficult to interpret at present. Three walls seem to run parallel through this space but do not completely divide the room (Figure 4). Two of the walls are significantly slumped to the south, leaning on top of Aeolian sand fill. WT, the northern most wall, is the most vertical and extends the farthest forming one side of Rooms 41 and 36. Room 36 has been reported on before, but it is interesting to note here that this section of WT is lifted and twisted as a result of the earthquake waves uplifting and moving the ground beneath the building. These three walls as they exist in Room 35 appear to have been partially destroyed in the earthquake and decayed over time, slumping under their own weight onto sand that infilled after the building was abandoned. This process formed what appears to be a bipartite or tripartite division. Future work in this area will test the hypotheses that this series of walls formed a divided storage area, a tripartite entry way, part of the stairway that led to the second floor or second floor walls.

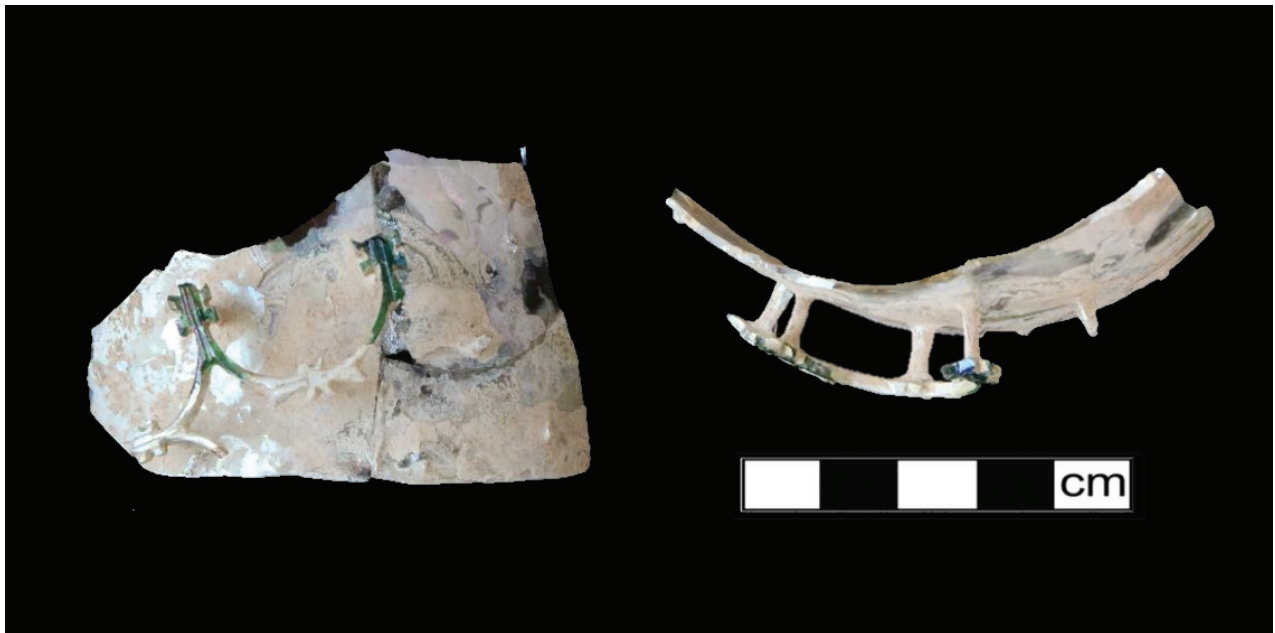
*Figure 5: The restored fragments of the cage cup found in Room 35.*

fifty fragments have survived (Harden 1987). Perhaps the most famous cage cup is the Lycurgus Cup made from dichroic glass, now in the British Museum (Online 2019). The fragmentary cage cup found in Building 4 was probably once clear glass with a clear or milky white and green cage. This colour combination is similar to the Cologne cage cup in the Romano-Germanic Museum in Cologne; this cup is decorated with a raised glass inscription in Greek reading ‘Drink, live well forever’ (Trier and Naumann-Steckner, eds. 2016).
